# Home Inspection Report

Prepared for: John Client

123 Some Street Somewhere, US 12345

Inspected by: John Schuler J & H Home Inspections

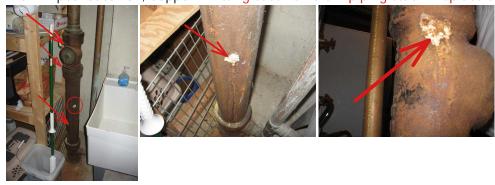
4. Drain Pipes: Cast iron, Copper - Pitting cast iron drain piping stack - replace affected sections where required
